Here is a comparison of before and after with the different ice damn's.

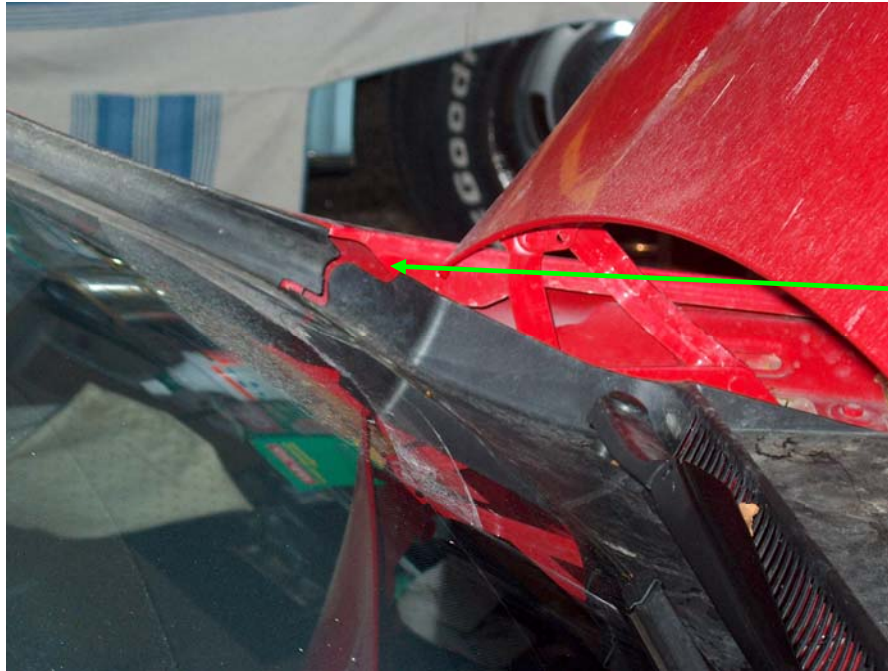
BEFORE

At the drivers side junction of the windshield gasket and the apron at the bottom of the windshield is a gap.

This gap allows water from melting snow to flow back into the area where the door hinge is

This gap was much larger on my driver's side of the car in comparison to the passenger side.

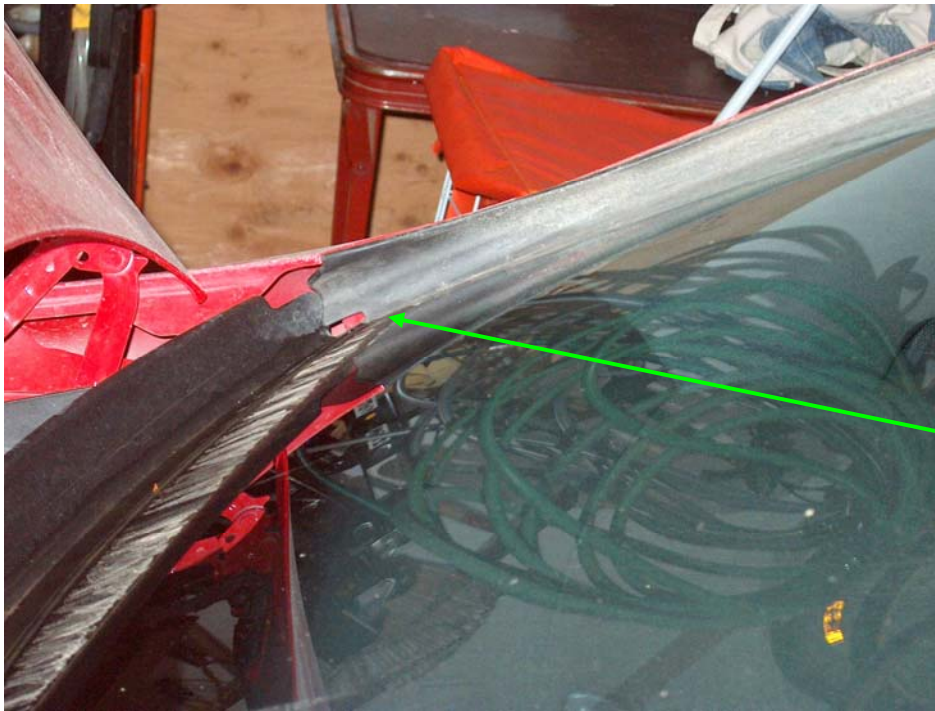
BEFORE

A smaller gap but there is still a gap, and there was ice built up on the passenger side as well, but not enough to damage the door.

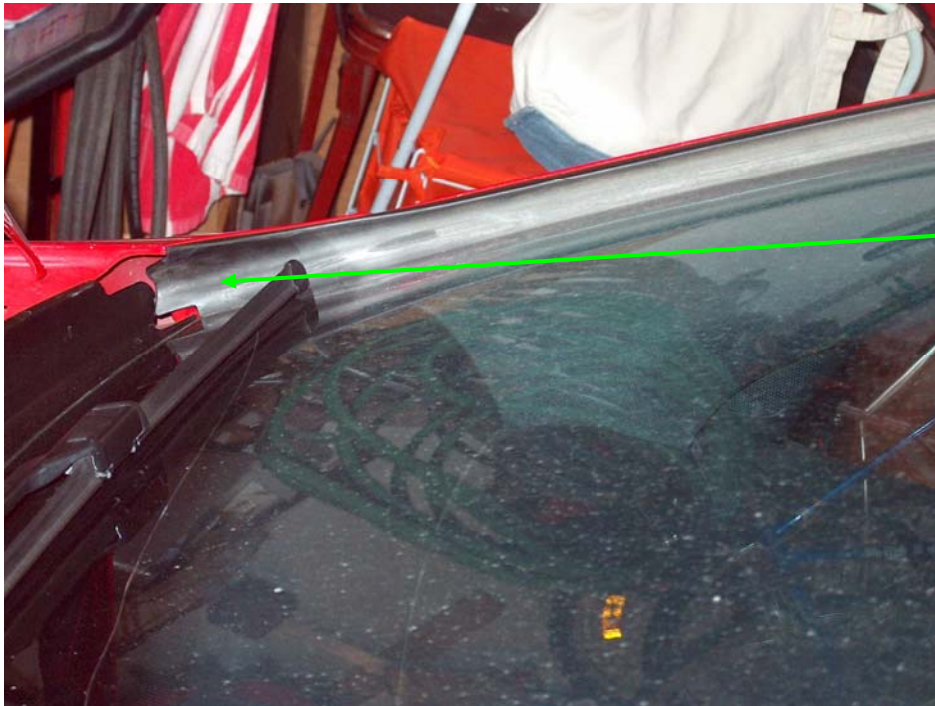
AFTER

Not significant change on the passenger side, when compared to the driver's side.
