Technical Bulletin

| Model(s) | Year | Eng. Code | Trans. Code | VIN Range From | VIN Range To |
|---|---|---|---|---|---|
| Rabbit, GTI | 2006 - 2007 | All | All | All | All |

57 07 05 April 23, 2007 2014599

Front Door Deformed by Ice

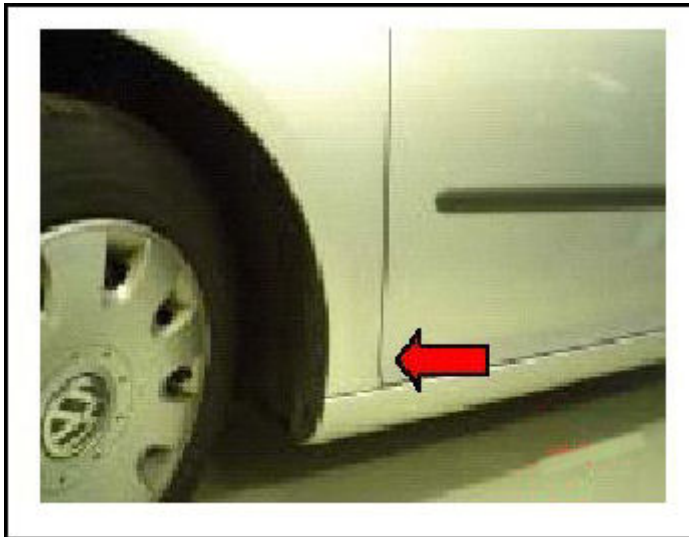
In cold climates door(s) becomes damaged in the lower area while opening.

Water draining from the front cowl drains into the rear of the front fender area. Water seeps out behind the lower front door and freezes causing door obstruction and damage to door panel.
