Thread: [DIY: MKV Headlight Level Sensor Linkage Fix](#)

Vehicles: 2007 Jetta GLI

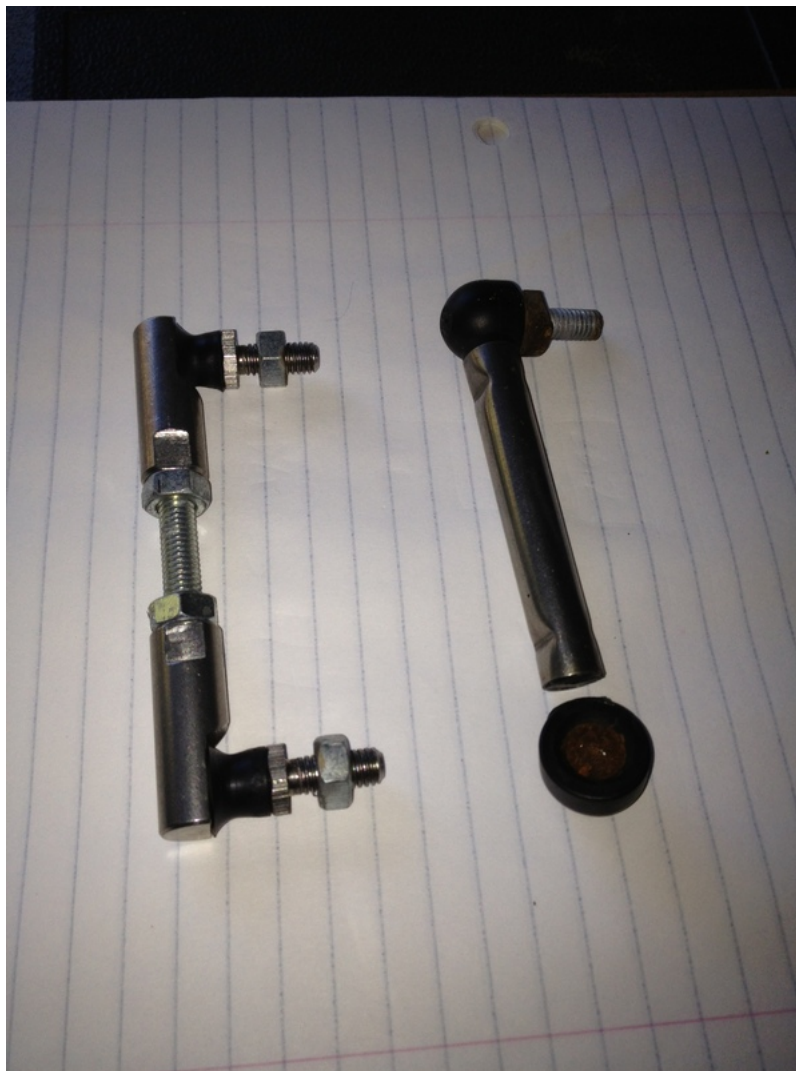
I picked up a MKV GLI a few weeks ago and noticed that the front linkage for my auto level sensor was broken. I tried to search on how to replace this part but found out that it is only sold in a kit from Volkswagen for about \$180. That said, I decided to fabricate my own using off-the-shelf parts for less than \$20.

Old linkage on the right

New linkage on the left

3. Assemble new linkage. Screw two M6 hex/jam nuts to the middle of the M6 rod. Screw a linkage on bolt sides of the rod until they bottom out. Back both linkages off equally until the correct length (3") is obtained. Lock the linkages in place with the hex nuts. Apply loctite or strong glue to the hex nuts after tightening to ensure they will not come loose.

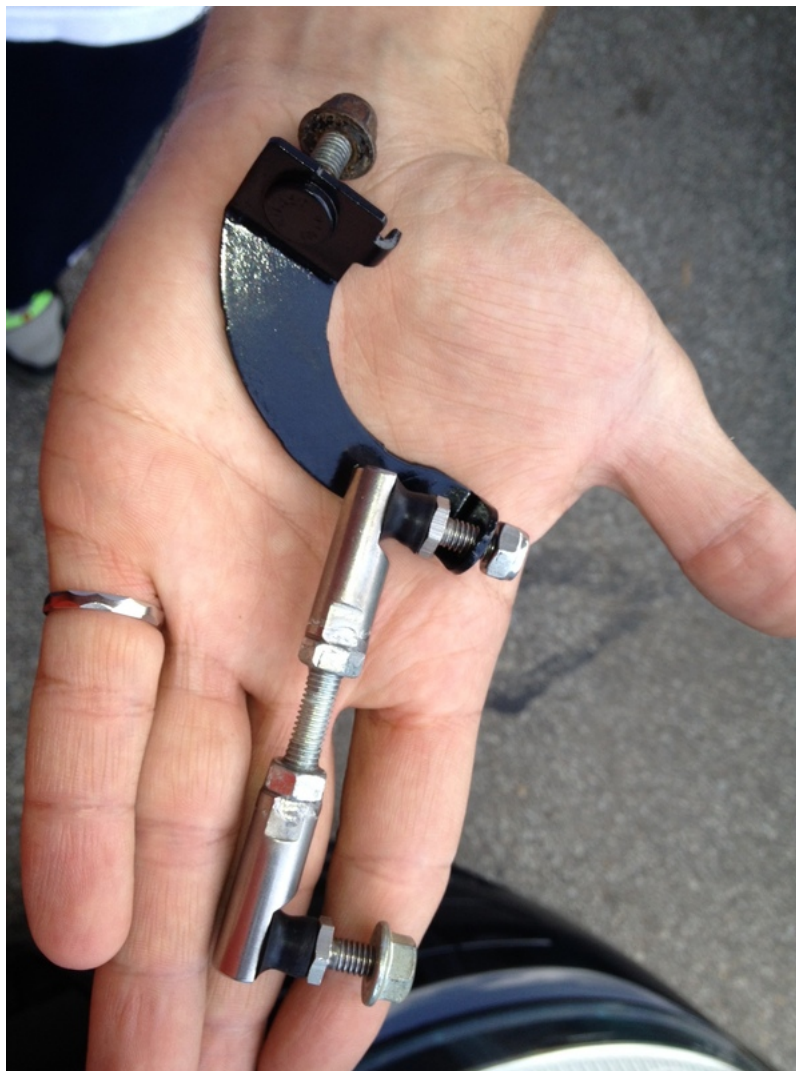
The completed rework assembly
