[Club Touareg Forums](#) > [Club Touareg Technical Forums](#) > [General Maintenance & Repair](#) > [DIY: How to repair an RN S2 DVD \(a.k.a. MFD2\)](#)

DIY: How to repair an RN S2 DVD (a.k.a. MFD2)	
Touareg: 2006 V8 Join Date: Aug 2010 Location: US Second Vehicle: Still looking Posts: 439 Thanks: 0 Thanked 1 Time in 1 Post		<p>My NAR 2006 RN S2 DVD, part #7L6 035 191 Q, had 3 scratches:</p> <ol style="list-style-type: none">1. The button you can press to accept the liability disclaimer (damn ambulance chaser lawyers)2. The RADIO button3. A nearly imperceptible scratch on the music symbol button <p>VW in the U.S. will not repair, only sell replacement. I sought repair of mine at a British place which offers Blaupunkt repairs. They even list #7L6 035 191 Q on their website, for instance. But they informed me Blaupunkt in reality does not sell them any parts. For a "core" fee of only £1250 + the shipping costs two ways, Blaupunkt would offer me a replacement unit, remanufactured, I believe.</p> <p>So I purchased on eBay a used, made in July 2007, RNS2 DVD, with code provided. The unit was evidently a European version, as it was a 7L6 035 191 S, and instead of a RADIO button it featu

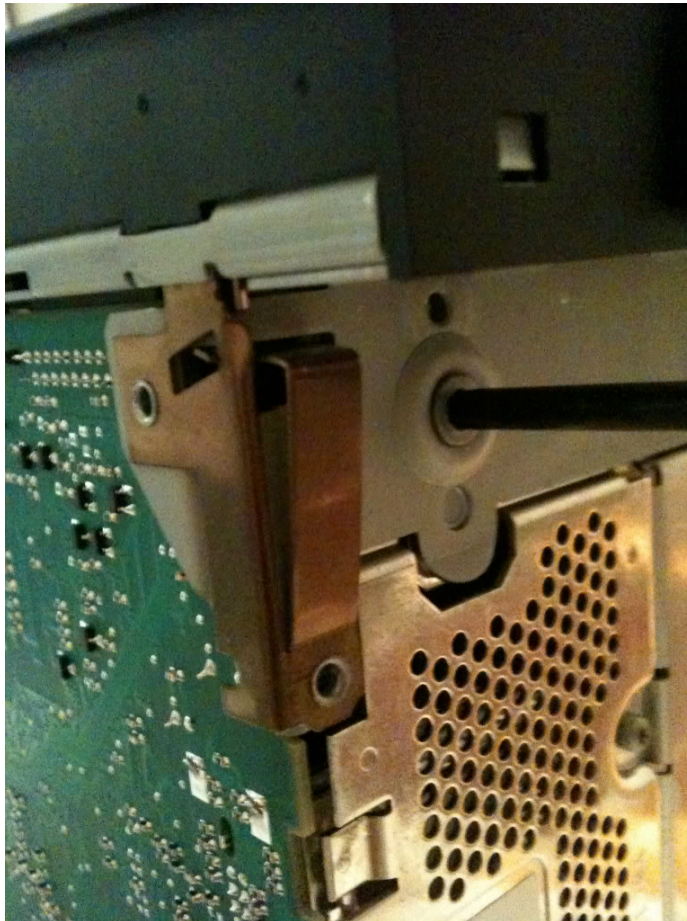
The next step may be unnecessary and I do not like it. Turn the RN S2 upside down. Remove the bottom horizontal cover by removing three torx screws from the bottom cover, screwing down towards the top of the unit when properly installed. The cover will slide backwards revealing a couple of horizontal tabs inserted towards the front of the unit. I don't like this step because it leaves exposed the bottom of the motherboard with all its hundreds of solder points. Treat with enormous care.

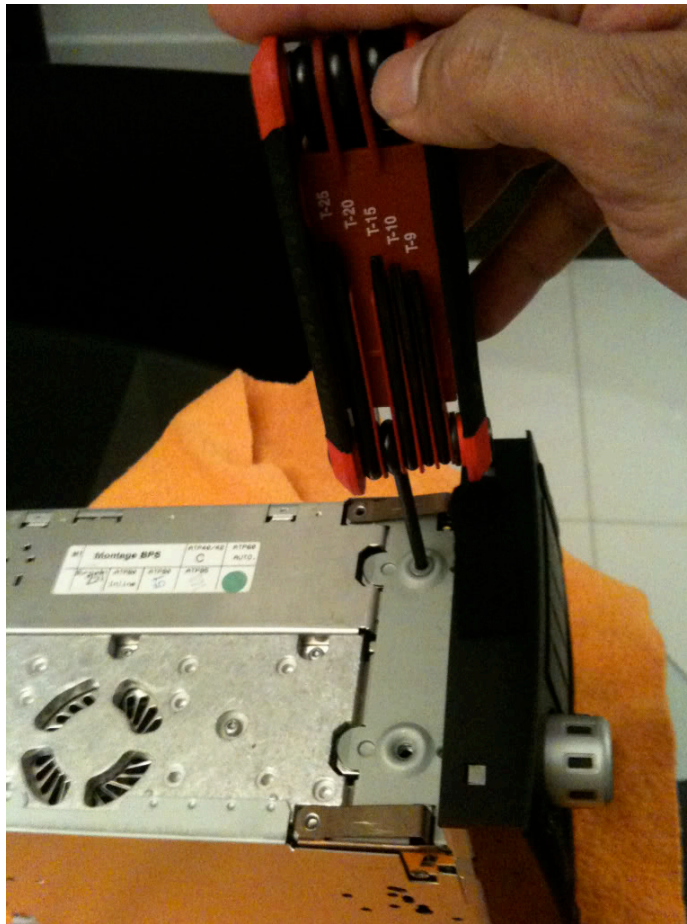
Now the fun begins. On the sides of the RN S2, you will see 4 large #20 torx screws (2 on driver's side, 2 on pass). Unscrew them. These screws screw into 4 sort of ledges, leaves or tabs coming from the front of the unit. Insert a flat screwdriver between such tabs and the main body of the RN S2, so as to "open" them or reduce the amount of pressure between them

and the main body. Don't over do it, but loosen such pressure a bit.

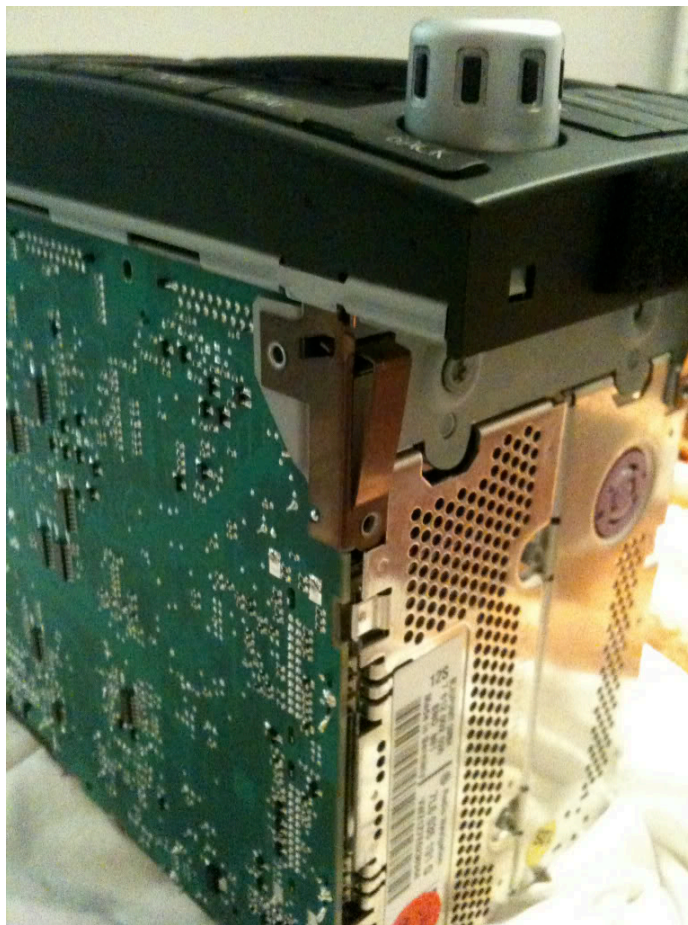
Now pull the front of the radio containing the screen, user buttons, and first half-inch of metal or so to separate it from the cube with the innards! At first you may feel the top of the radio wants to yield but not the bottom. You have to pull evenly. The reason the bottom does not want to yield is that there are six computer contact connectors from the middle of the radio towards the bottom; so after you removed the big #20 torx, what holds the front is the pressure of the 4 tabs where the #20 torx go + the pressure of the 6 computer connectors.

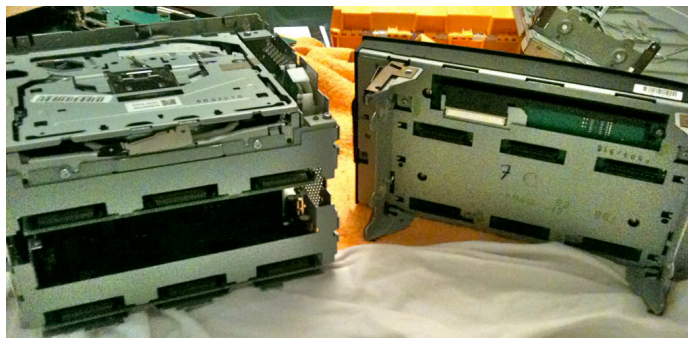
Just pull, there is nothing to break if you pull evenly and all at the same time. You may want to have someone help you.

Once you separate the fascia from the main unit, put aside the main unit.

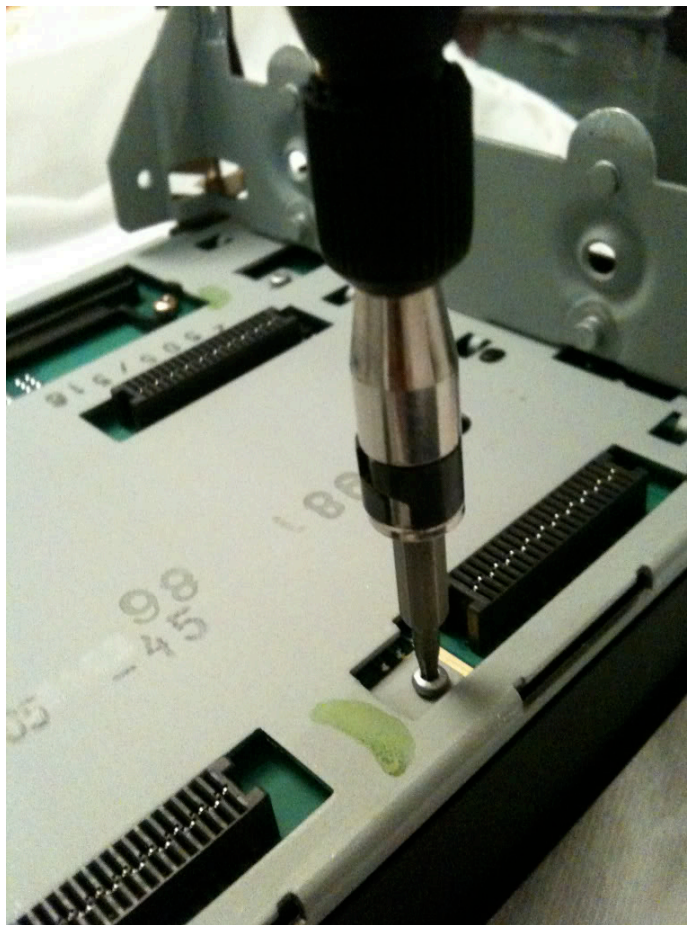
Put the fascia facing down towards the desk. You still have it on the soft cloth or towel... you don't want to scratch fascia, buttons or screen. On the new "top" (i.e., actual rear of the fascia) you will find 6 small silver or blackened torx. DO NOT TOUCH THE GOLD TORX! 4 are inboard in the area right behind the screen and 2 are outboard.

Afterwards you will have 3 separate components:

No. 1 the black plastic fascia, including most buttons;

No. 2 the electronics containing the screen, the button backlights and springs and the two rotary knobs;

No. 3 the metal chassis which supports the fascia and is the physical connector where the #20 torx fasten to the main body.

If you exchange part No. 1, for instance, you get all new buttons and new fascia. If you exchange part No. 2, you get all new screen and rotary buttons. **Instant repair!** You might also exchange DVD drives if that part is failing.

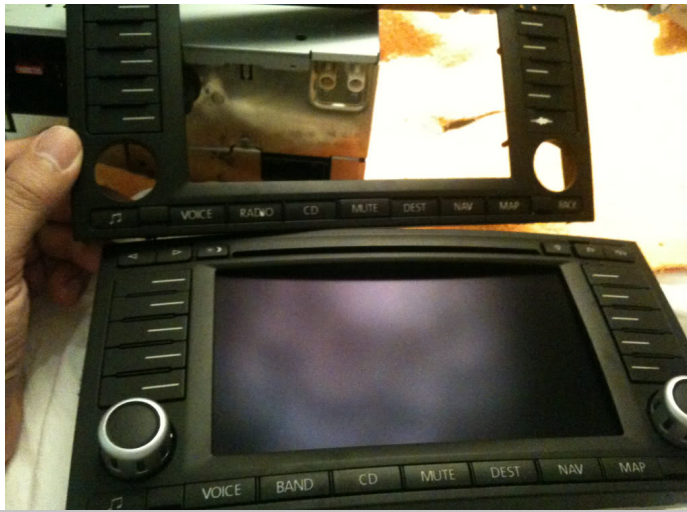
In this case, I went a step further. Each button consists of two parts:

a) The user side, black with unpainted surfaces for the letters or symbols

b) The inside, transparent plastic to transmit the button backlight.

If you insert a small flatblade screwdriver from the inside of the fascia, between a) and b), they unclip. a) slides outfront, b) slides out towards the back. You can then replace a)'s and the replacement buttons just click back in place with their transparent b) correspondents.

Whereas most larger buttons will happily unclip and clip several to many times, the small buttons will break every time: in my case, I tried with the MUSIC icon and the BACK buttons. Once you unclip black button from transparent back, their tiny clip is broken. Solution, a drop of crazy glue gel in between the black and transparent components. Just make sure the crazy glue does not get anywhere else but the sandwich black/transparent.
