# **GUIDE TO GENERATION 4 HALDEX TROU**

Applicable Vehicles - Typically Post 2008 Confirm via ECU part numbers on this page below - can be i

#### System Overview – The system components

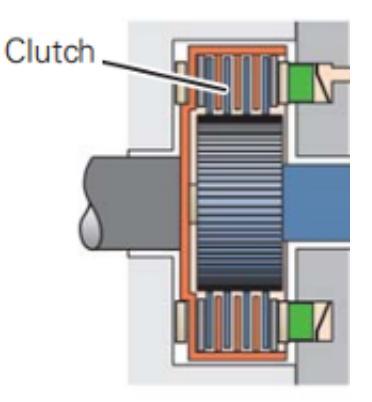
- Oil pump with strainer gauze "Haldex Clutch Pump (V181)"
- Filter cartridge
- Pressure Accumulator (a piston with a spring which holds a pre charge pressure for instant demand)
- Oil Control solenoid "Valve for Controlling Clutch Operating Angle (N373)"
- A wet clutch pack like a motorcycle clutch, which is clamped together with a piston type actuator built into the assembly
- ECU which is a slave to the ABS/TC/ESP ECU

Accumulator Filter Ca

Pre Strainer on

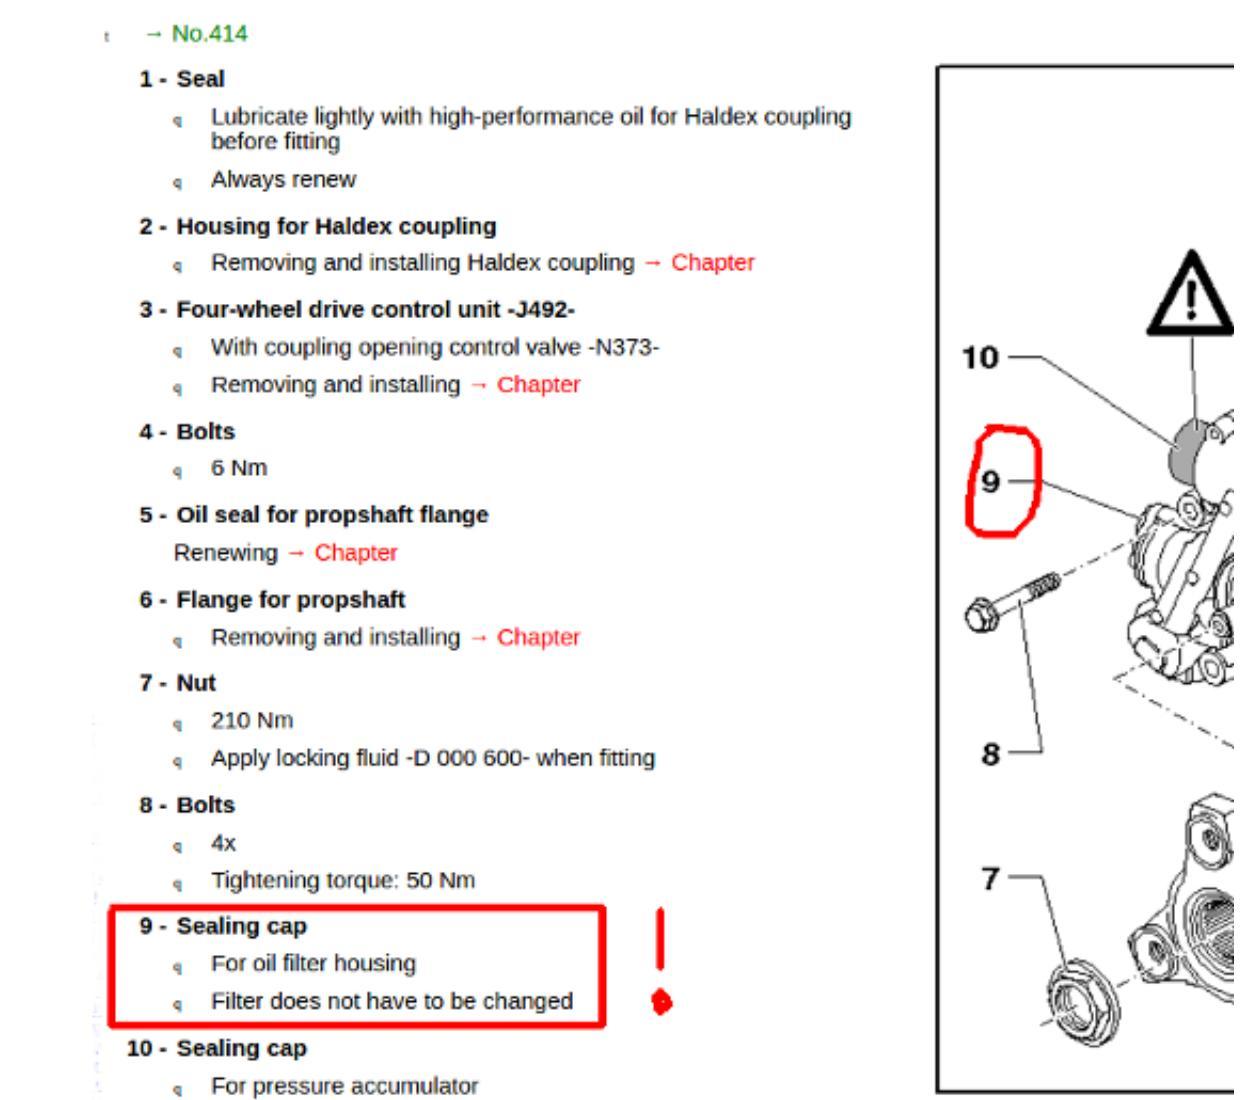
# (generation "Haldex IV"), rear final drive "0BR", "0BS" and "0BY"

When the ABS/TC/ESP ECU detects the front wheels are rotating faster than the rear wheels by the ABS Haldex Clutch pack, thus engaging the 4wd system. It is very fast at responding, it typically engages the slippage. It then holds the 4wd system engaged until the Torque request from the Engine ECU drops. The engaged.

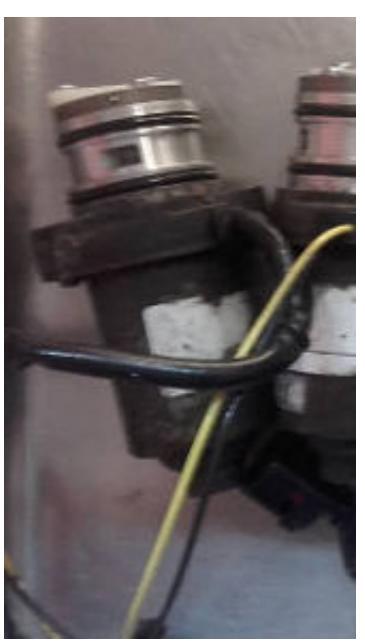
You can test the pump with a multimeter set in the Resistance "ohms" setting, and connect it to the two terminals in the pumps multi plug, polarity does not matter.. A good pump will measure between 5 and 8

ohms. Below or above this spec highlights a defective pump. Bad pumps often read very high resistan pump to make it run is an option, but it is far from any kind of conclusive test method. Some pump will cycles then test out of spec the next, this is due to worn motor brushes and commutator.

Pumps burn out typically because the filter clogs up with scum. Typically cars clog the filter between 4 the clock with a clogged filter. There is no set mileage, more down to activation/use of the Haldex clute If replacing the pump ALWAYS replace the filter. It is a consumable, and if clogged the new pump will k

Hald V181 Resolution:-

Replace Filter + Pump + Oil using correct method. **Buy Gen 4 Pump** Here(https://www.haldexrepairs.co.uk/shop/pumps/0ay598549ageneration-4-pump-haldex-vag/)

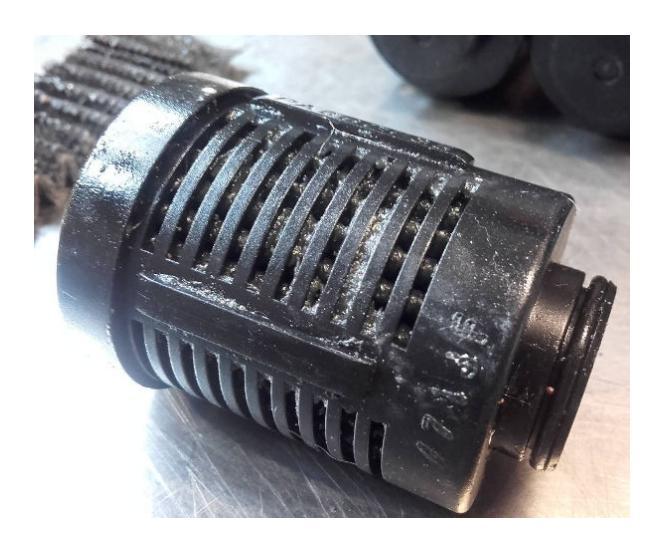
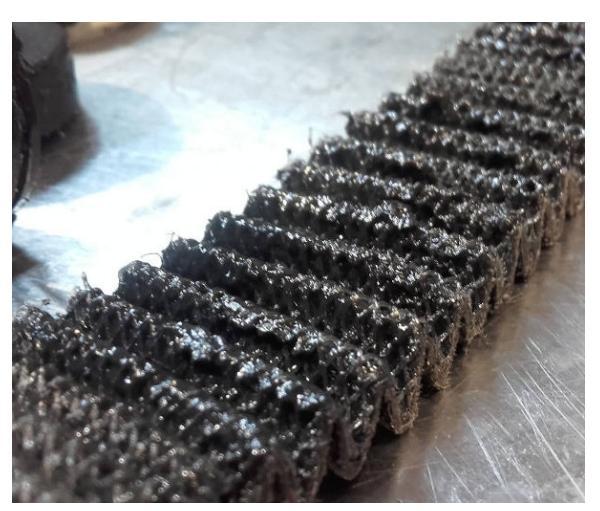
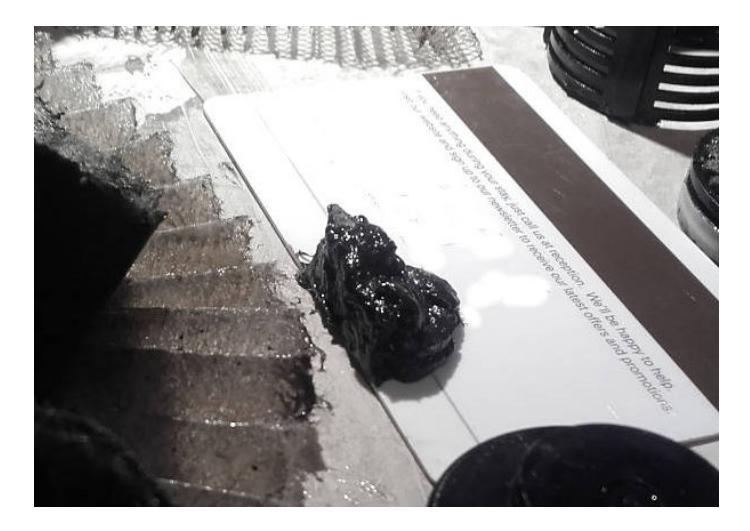
The clutch pack wear material is suspended in the Haldex coupling oil. Firstly large particles get filtered residue/particles get filtered by the cartridge filter. According to VW/Audi this filter does not exist!! Because oil is not passing through the filter cartridge, the oil pressure required to clamp the Haldex clu clutch pack slips (causing more wear and clogging the filter further!) thus the ABS/ASC/TCS system de should not be possible with the Haldex clutch engaged, thus the fault codes generated are focused of CAUTION – a Haldex pre change pump V181 which no longer delivers good oil pressure will also give the

Replace Filter + Oil + Clean pump pre filter. Often replacement pump is required. **Buy Filter Kits** Here(https://www.haldexrepairs.co.uk/shop/filters/generation-gen-4-filter-kit-vw-audiseat-skoda/)

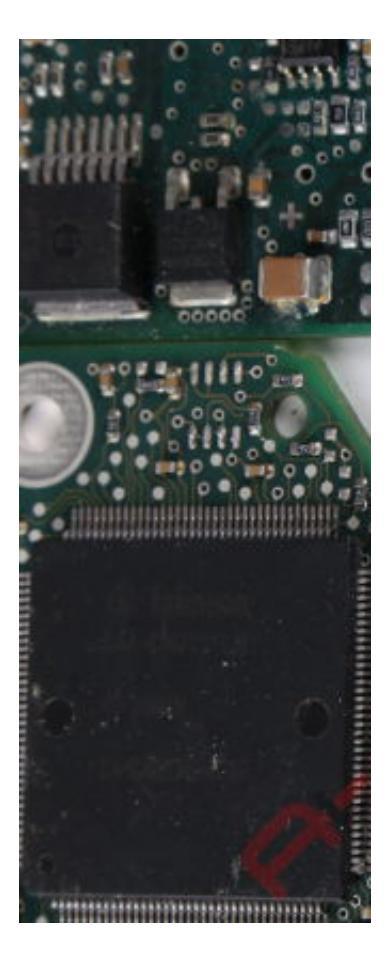
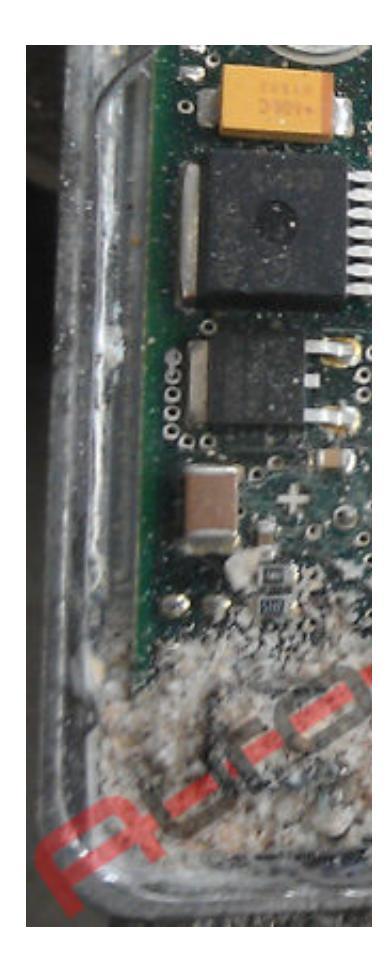
This can manifest itself in sneaky ways on Generation 4 Haldex vehicles. It can give any of the fault codes above, and even pump fault codes. As it depends which area of the circuit board is either corroded and/or burnt out.

The most simple way to prove the ECU is at fault is to open the ECU up. To do this, cut away all of the bl the lid – do not shove anything under the lid – do not scratch the circuit board or components. Then ir components on the bottom front edge of the circuit board. Around 15% of all Generation 4 Haldex failu many are viable for repair – depending on how bad the burning and/or corrosion is.

Resolution:-Repair or Replace Haldex ECU Replacing filter and oil is advisable Often pump is at end of service life too
