Technical Bulletin

40 08 01 Feb. 21, 2008 2017311

Front Suspension Creaking Noise

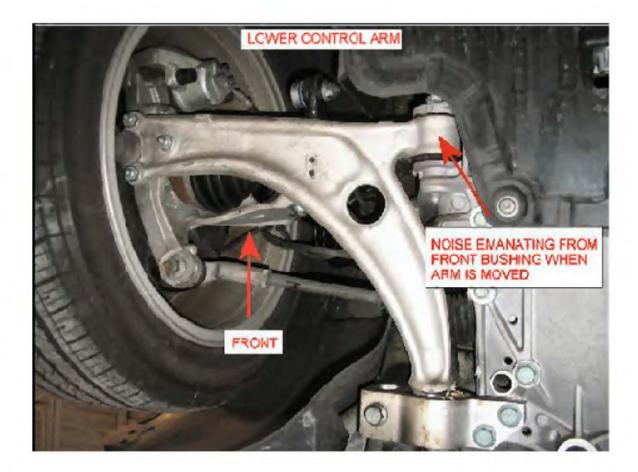
Bonded rubber bushing at front inboard attachment of lower control arm may be noisy.

To clearly identify if a noise complaint is related to this issue:

- Disconnect control arm from suspected steering knuckle.
- Move control arm up and down.

If a creaking noise is heard during motion:

• Replace the bonded front bushing (NOT the control arm), see Repair Manual Group 40 Front Suspension, Subframe, Stabilizer Bar, Control Arm, Bonded Rubber Bushing in ElsaWeb.
